UH-1 BALLISTIC AND BIRD IMPACT TEST STUDY

## UH-1 BALLISTIC AND BIRD IMPACT TEST STUDY

Goodyear Aerospace Corporation

Final Report

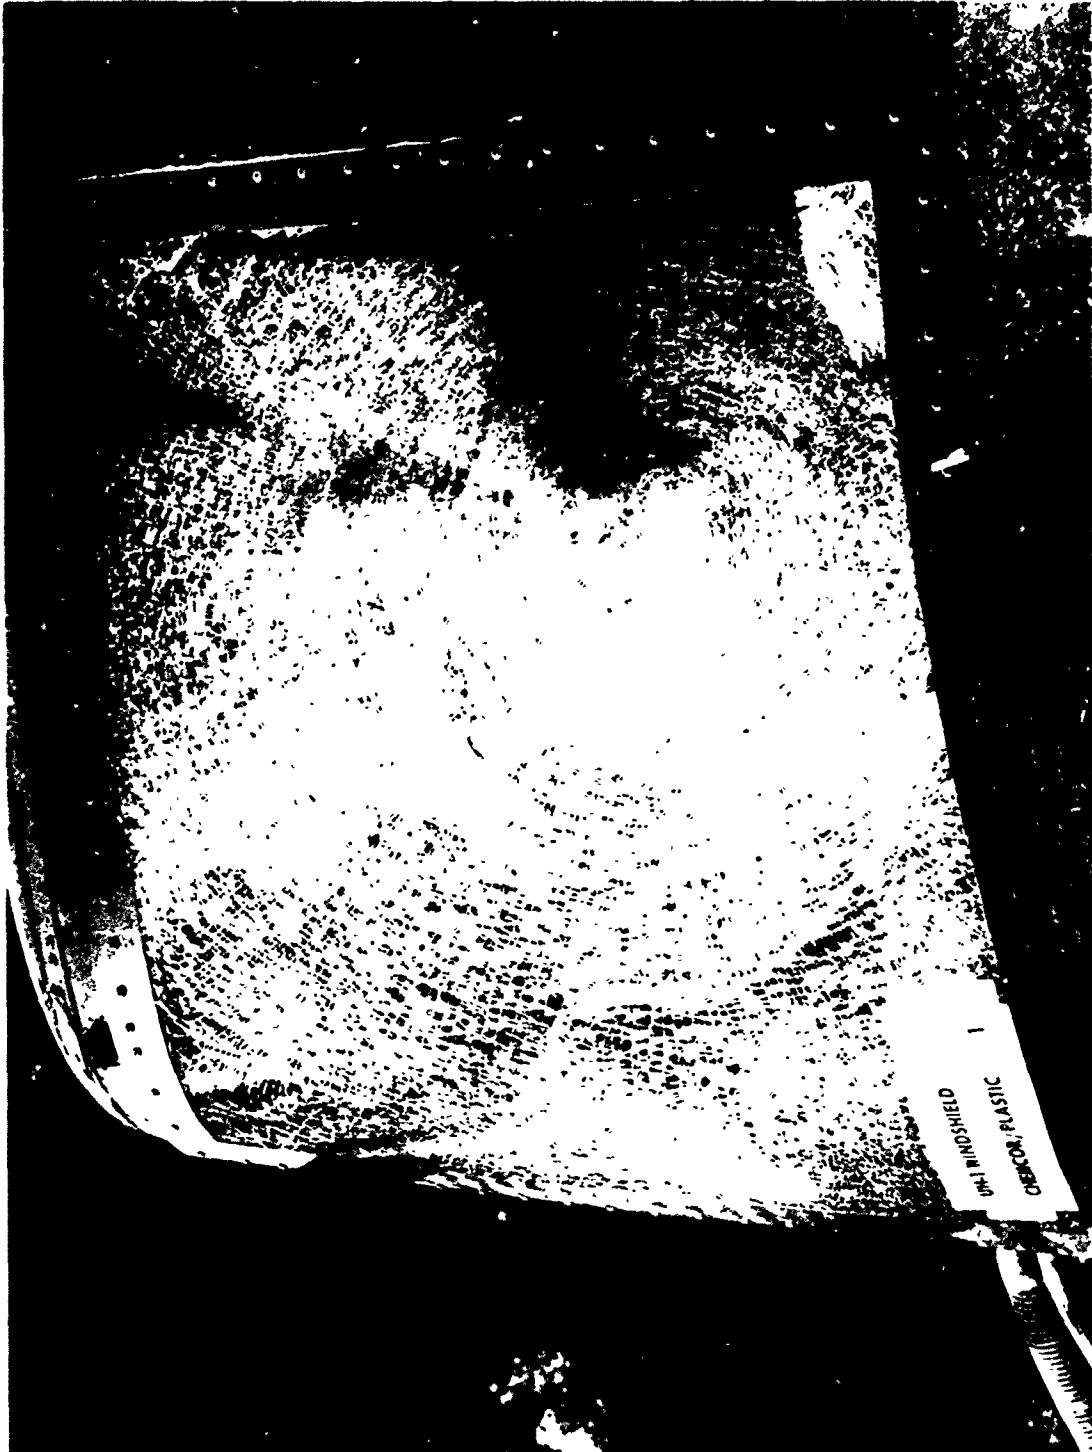
The fifth windshield tested was the no. 1 Chemcor-plastic composite. The bird was fired at 115 knots and failed to penetrate the structure. The glass and plastic broke on the lower inboard corner at the edge attachment and bent inward sufficiently to permit small glass particles to enter the lower part of the vacuum chamber (see Figure 24). The bird bounced upward and fell about ten feet from the aircraft.

Figure 24 - Bird-Impacted Chemcor-Plastic Windshield Number 1

- d. Chemcor-plastic composite offers bird protection from cruising speed (90 knots) to maximum redline speed (120 knots) of the UH-1 aircraft. Some breakage occurred along the edgeband transition of both windshields in the lower inboard corner. The breakage allowed spall to enter the cabin area. A redesign of the edge attachment is needed to withstand the bird strike loading.

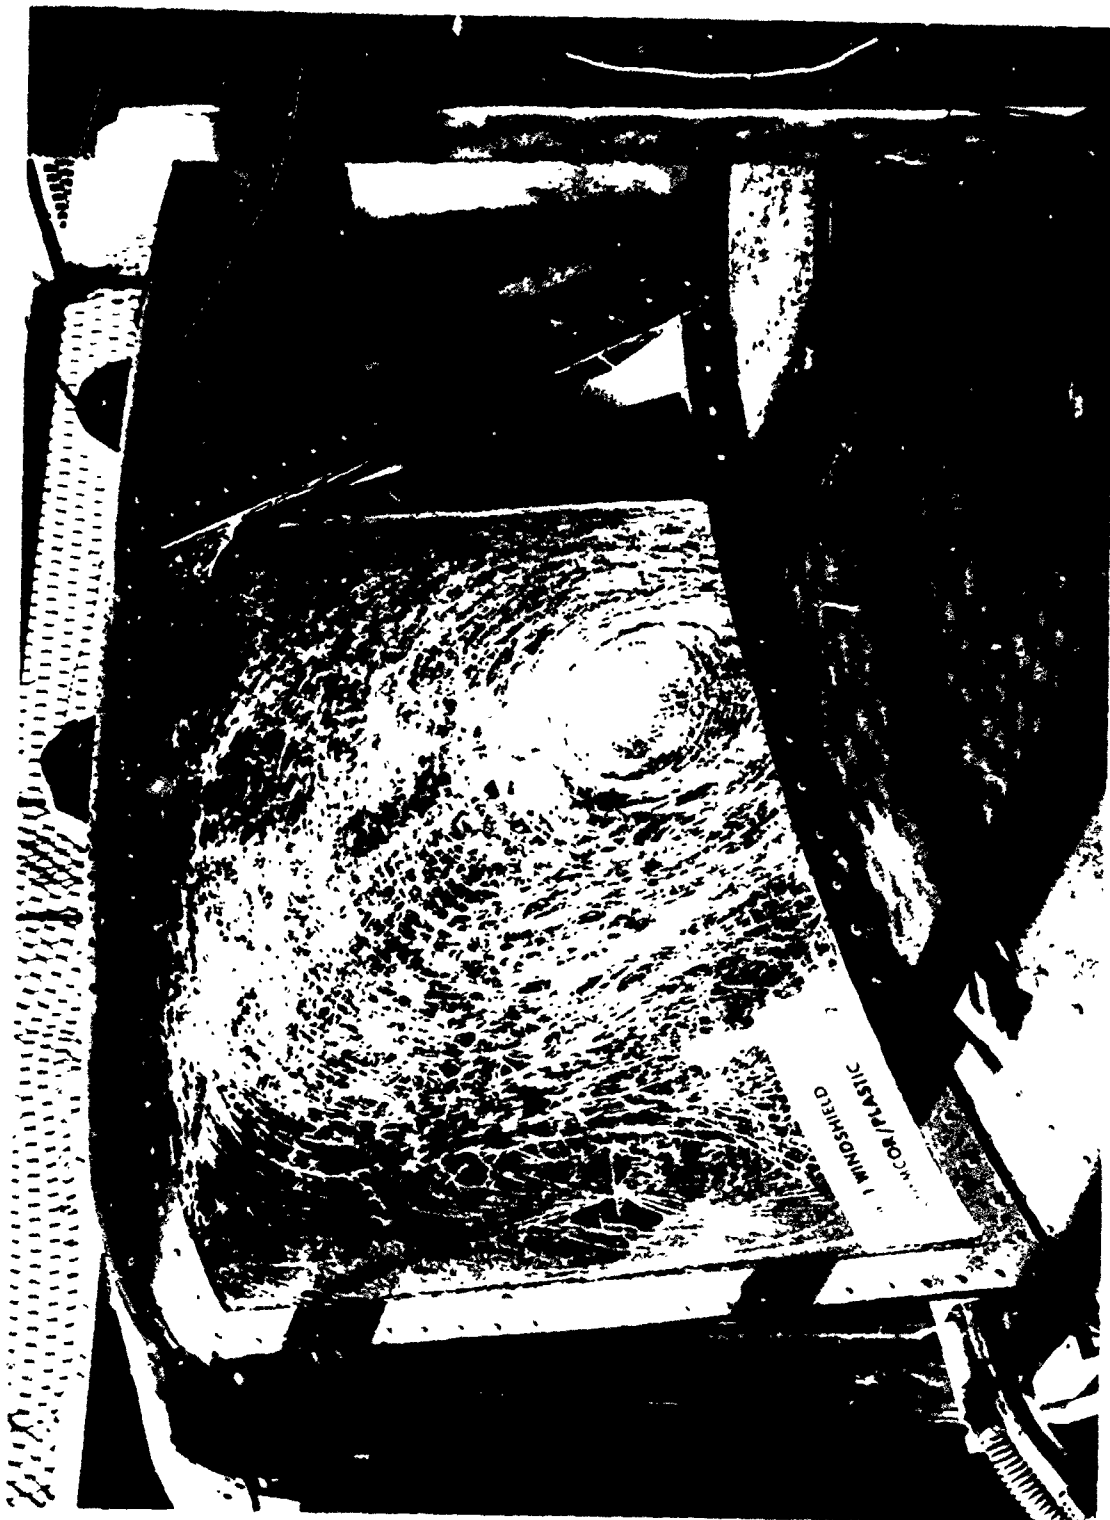
The second Chemcor-plastic windshield failed in a similar manner at 92.2 knots. No penetration of the bird occurred, but when the composite broke along the lower inboard edging, small spall particles entered the lower part of the vacuum box (see Figure 25). The bird bounced and fell approximately ten feet from the windshield.

Figure 25 - Bird-Impacted UH-1 Chemcor-Plastic Windshield Number 2
